THE OHIO STATE UNIVERSITY AIRPORT (KOSU)

AIRPORT MASTER PLAN

2022

APPENDICES

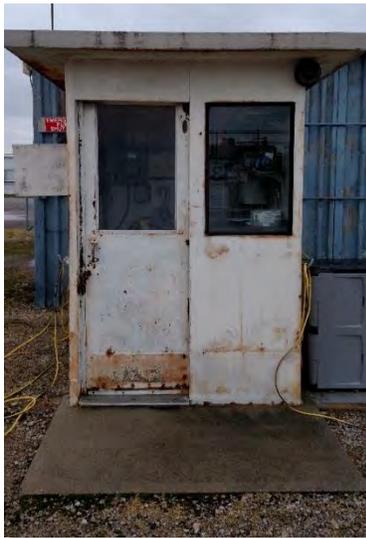
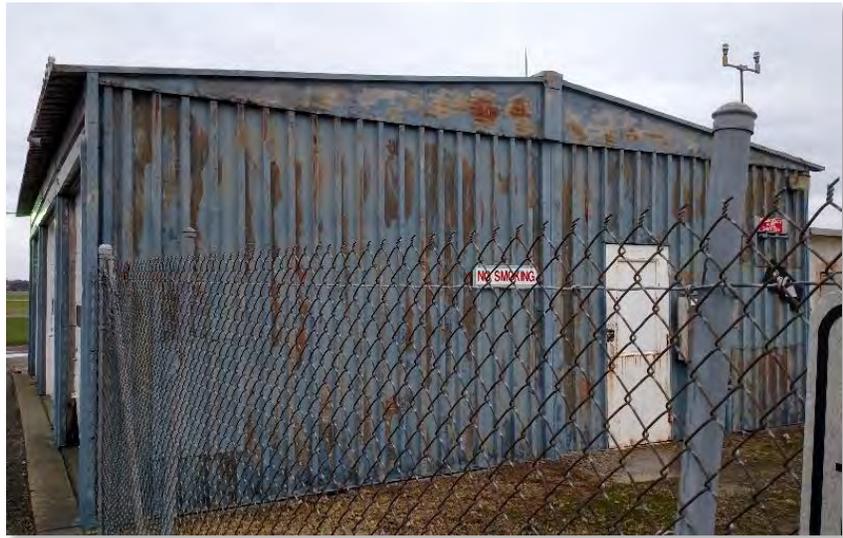
C.3 Building 0143 – The Paint House

Source: BCI, 2017

Condition: Poor

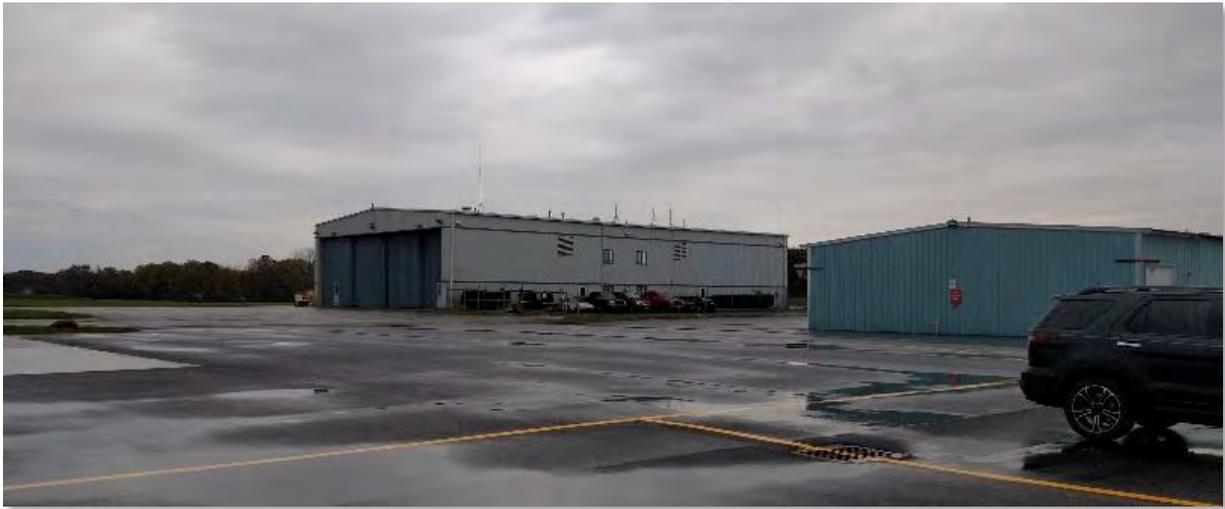
C.4 Building 0164 – Snow Removal Equipment Storage

Source: BCI, 2017

Condition: Average

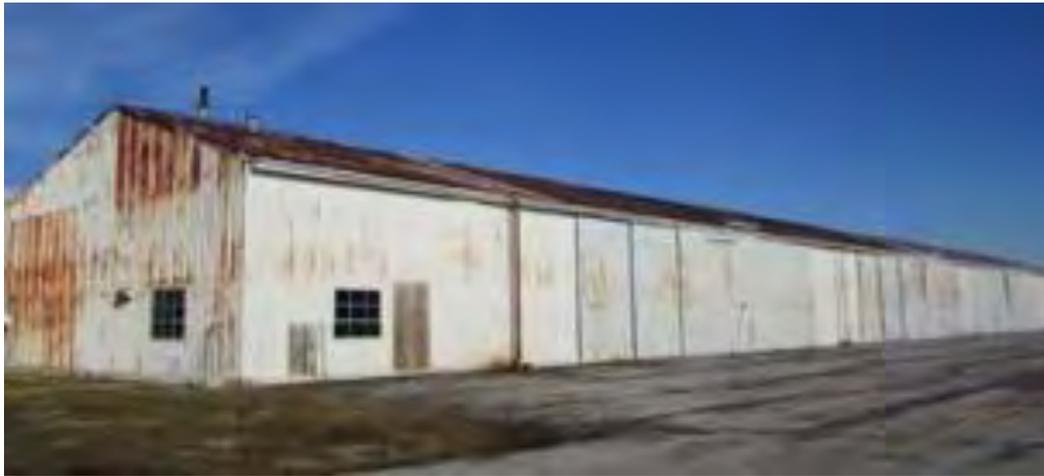
C.5 Building 0195 – Airport Storage

Source: BCI, 2017

Condition: Poor

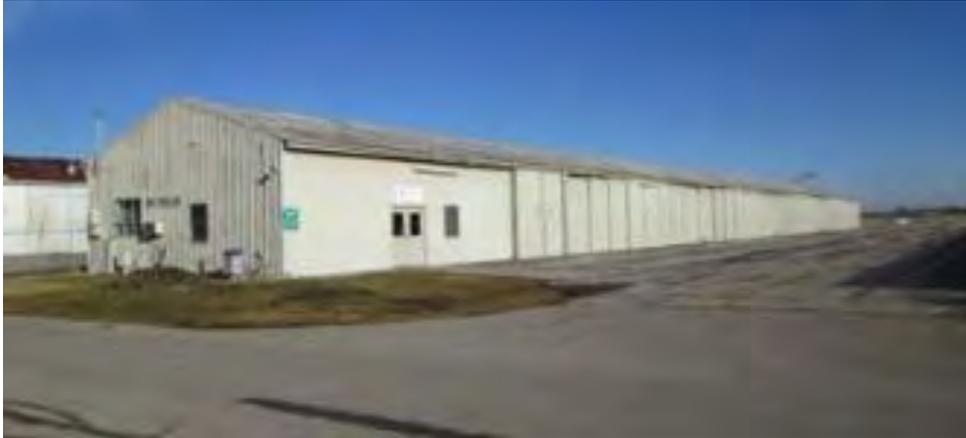
C.6 Building 0196 – T-Hangar A West

Source: BCI, 2017

Condition: Average

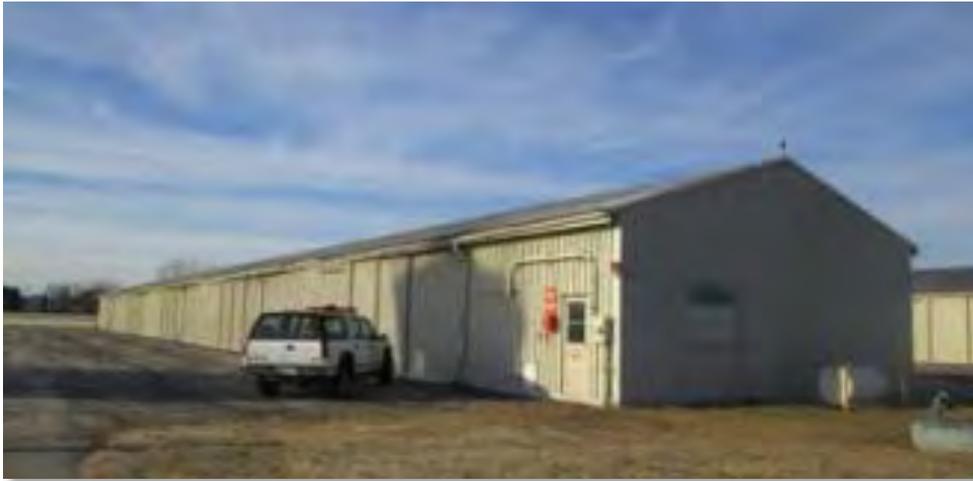
C.7 Building 0197 – T-Hangar A East

Source: BCI, 2017

Condition: Poor

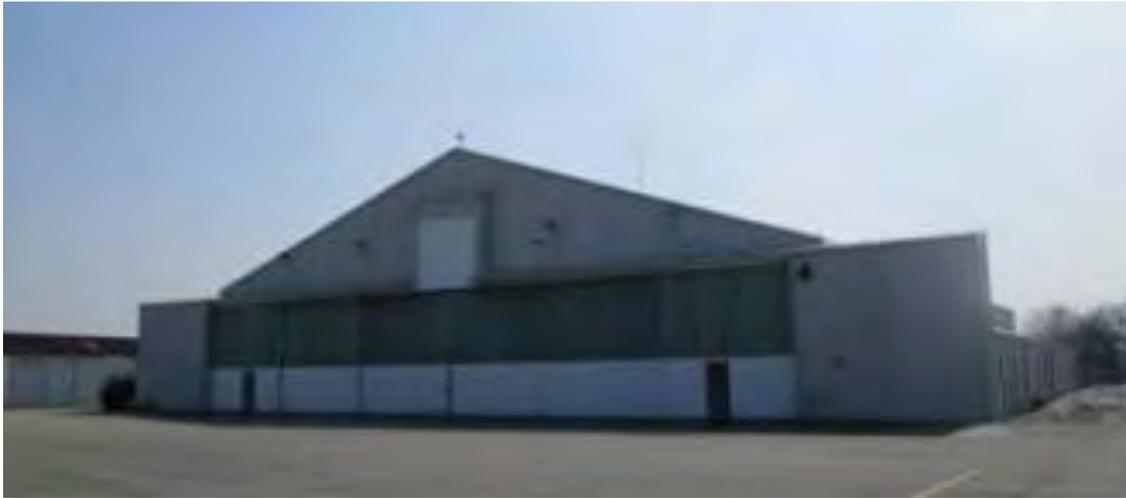
C.8 Building 0198 – Hangar 4

Source: BCI, 2017

Condition: Poor

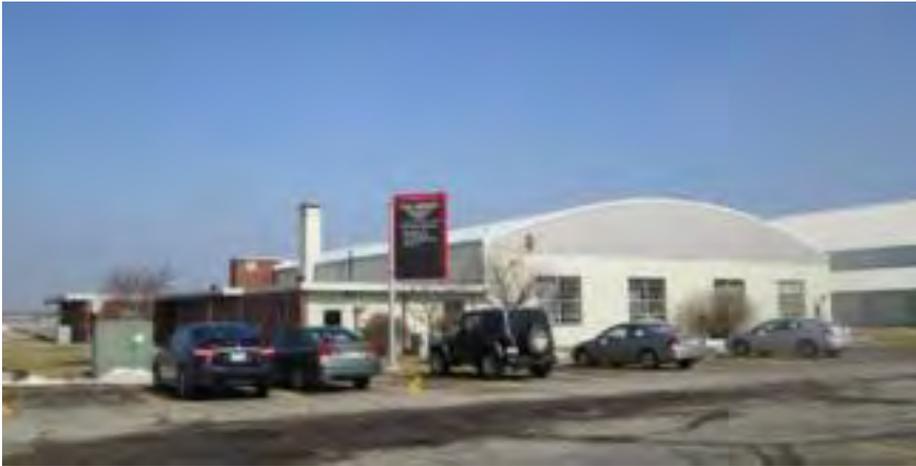
C.9 Building 0235 – Flight Laboratory

Source: BCI, 2017

Condition: Average

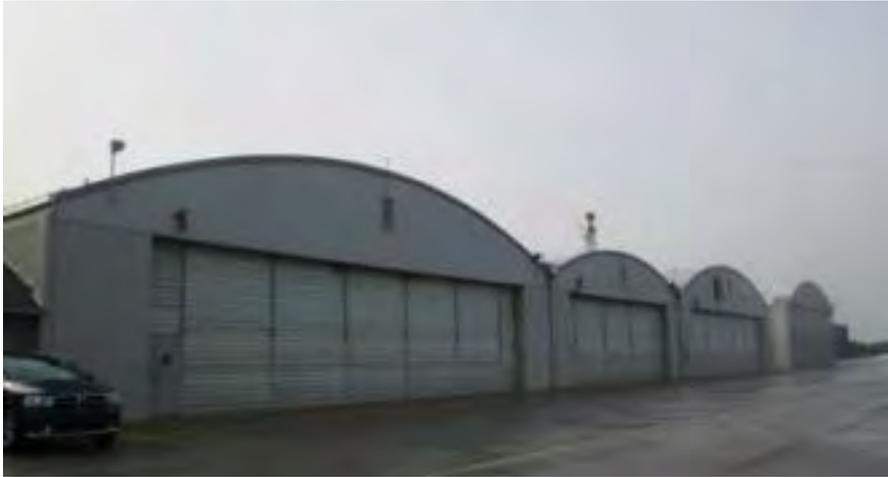
C.10 Building 0236 – Hangars 1, 2, and 3

Source: BCI, 2017

Condition: Average

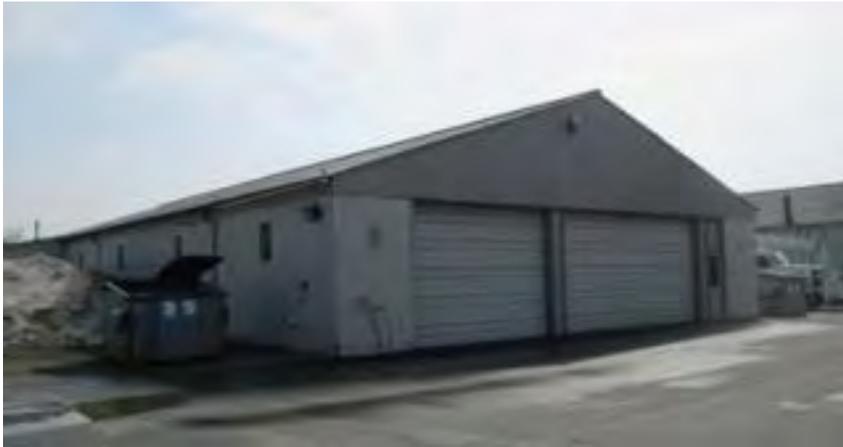
C.11 Building 0237 – Airport Maintenance

Source: BCI, 2017

Condition: Poor

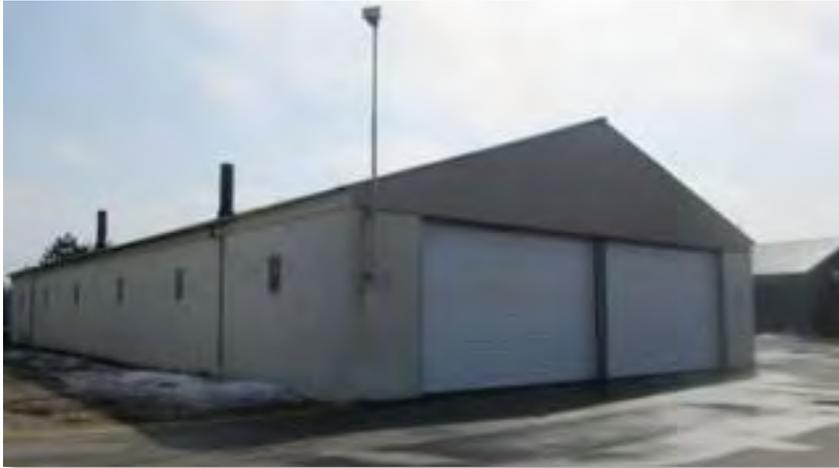
C.12 Building 0238 – Hangar 6

Source: BCI, 2017

Condition: Poor

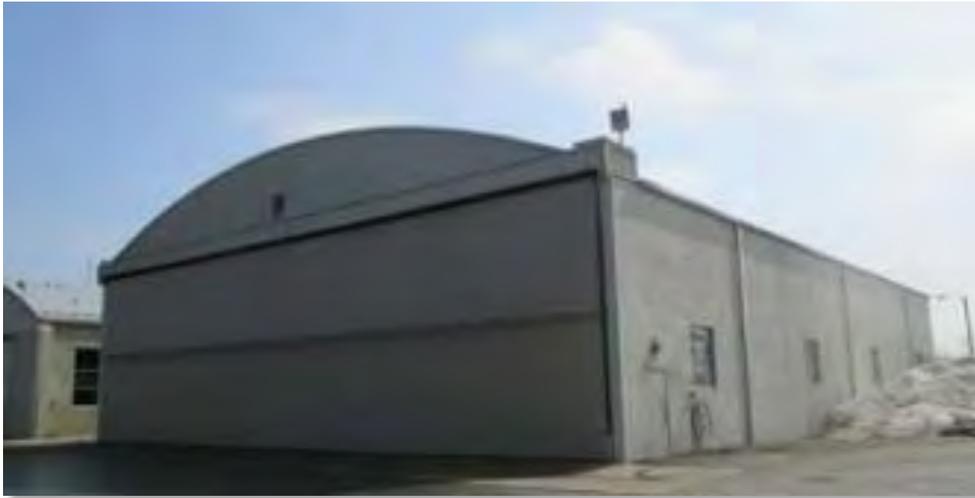
C.13 Building 0239 – Hangar 7

Source: BCI, 2017

Condition: Average

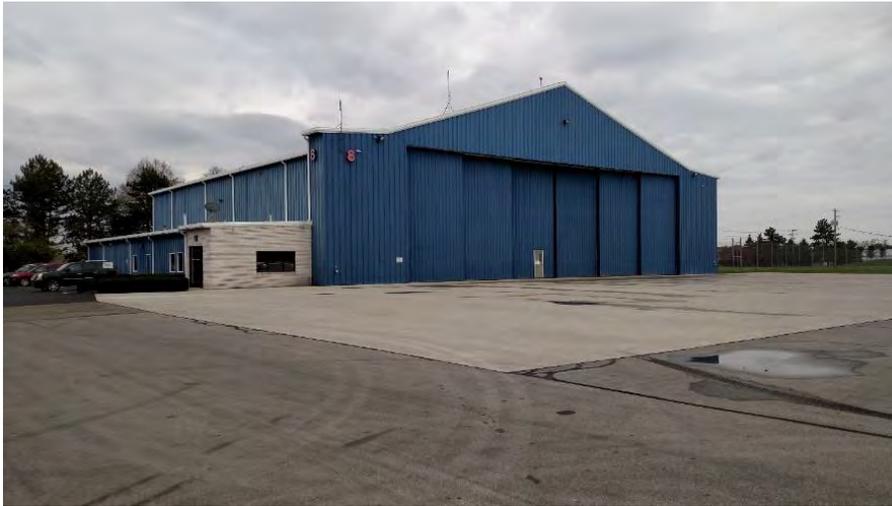
C.14 Building 0256 – Hangar 8

Source: BCI, 2017

Condition: Average

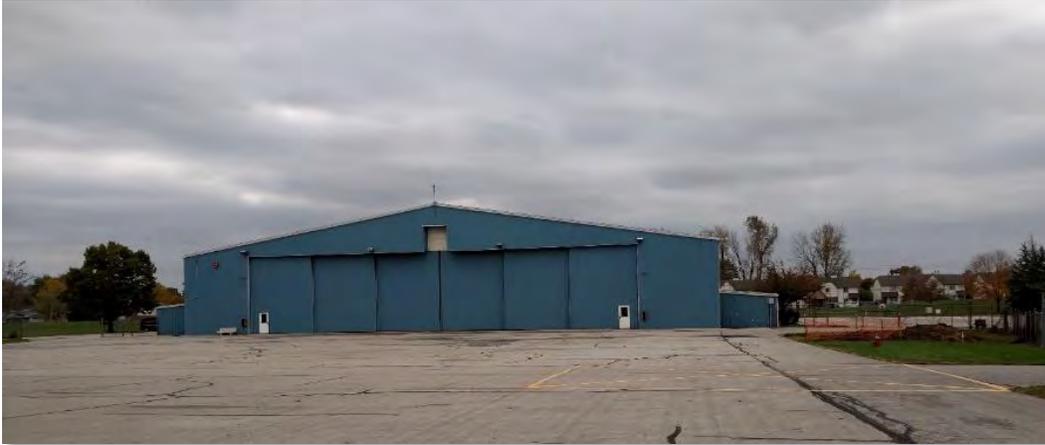
C.15 Building 0900 – Hangar 9

Source: BCI, 2017

Condition: Average

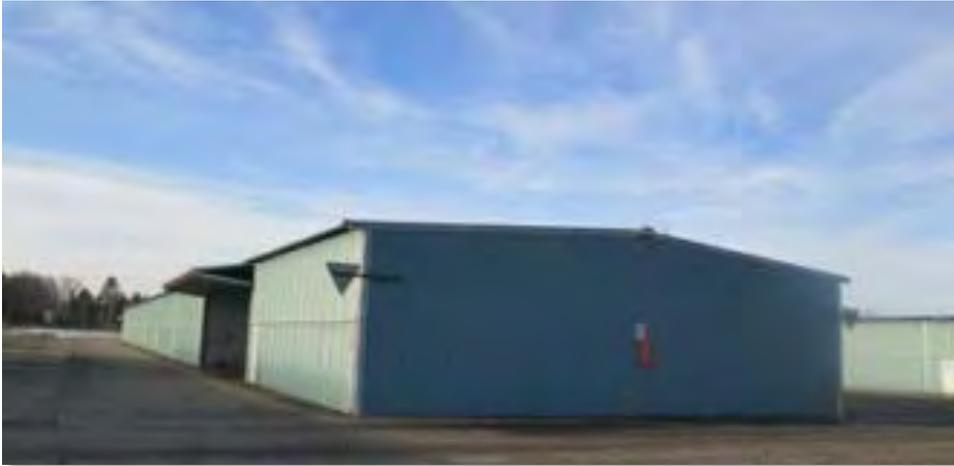
C.17 Building 0904 – Hangar D

Source: BCI, 2017

Condition: Average

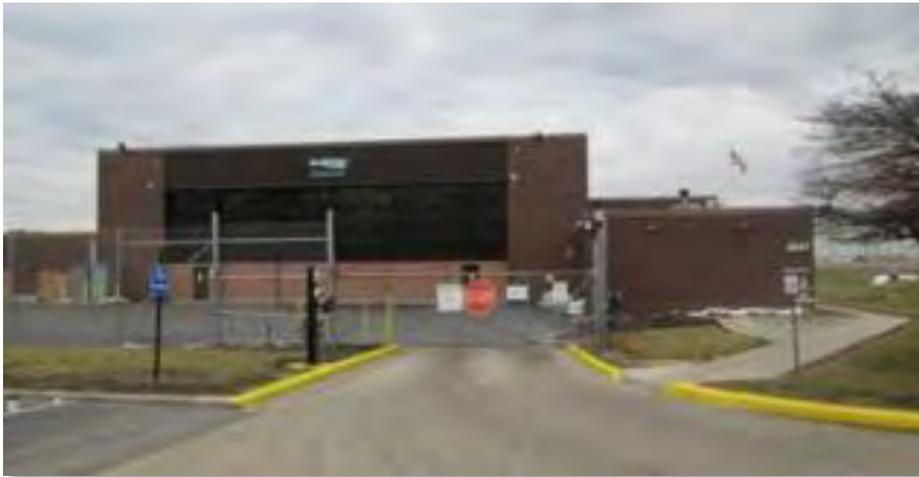
C.18 Building 0978 – Med Flight Hangar

Source: BCI, 2017

Condition: Average

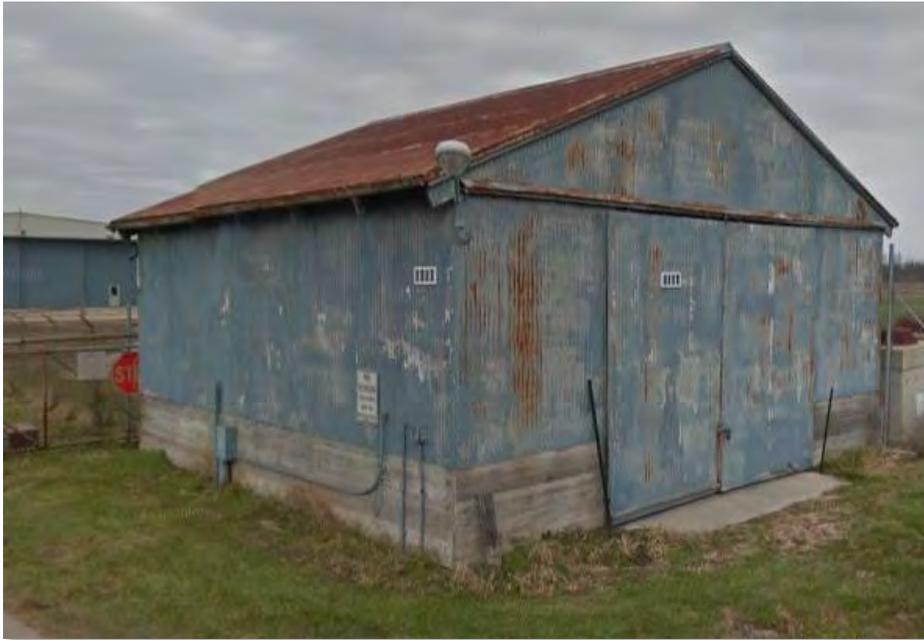
C.19 Building 0993 – Airport Blue Barn

Source: BCI, 2017

Condition: Poor

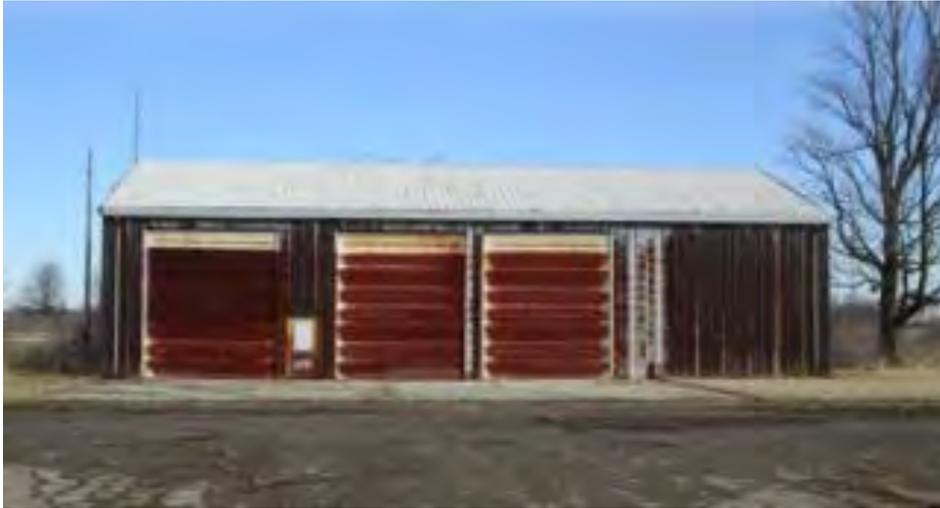
C.20 Building 1000 – Airport North Storage Hangar

Source: BCI, 2017

Condition: Poor

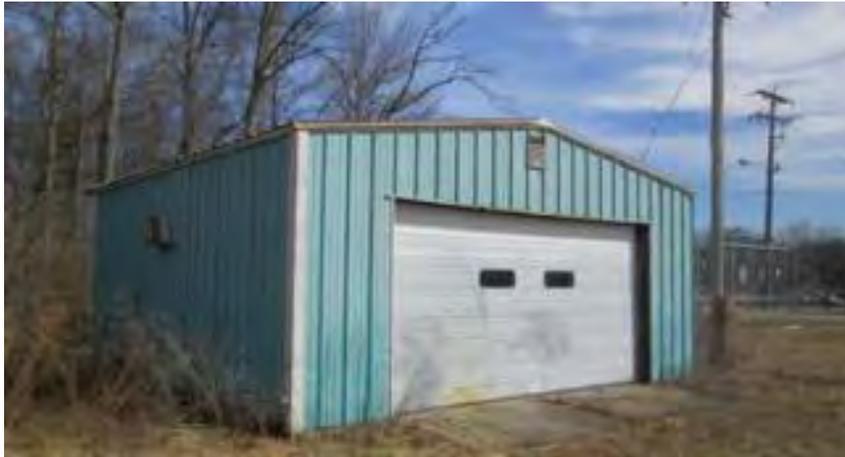
C.21 Building 1001 – Airport North Storage Shed

Source: BCI, 2017

Condition: Poor

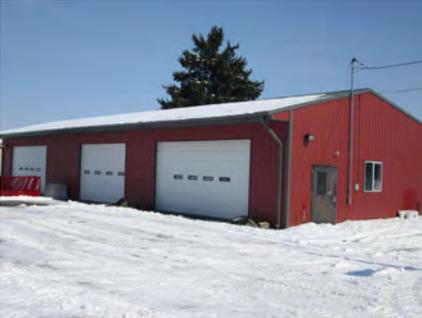
0330: Beef Barn Shop **82.49%**

Address: 2400 West Case Road, Columbus	Area: 2750	Construction Type: Wood frame w / Metal skin
Auditor: DMD & MAM	Date Constructed: 2004	Construction Type 2:
Audit Date: 03/02/2015	Last Renovation: NA	Structural Span: Varies 24'0"
Arch/MEP: 40% / 60%	LEED: NA	Historic Significance: NA

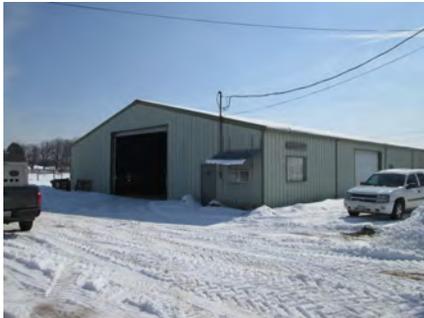
0982: Sheep Annex

Address: 2400 West Case Road, Columbus	Area: 6200	Construction Type: Steel frame w / Metal skin
Auditor: DMD & MDM	Date Constructed: 1976	Construction Type 2:
Audit Date: 03/02/2015	Last Renovation: NA	Structural Span: Varies 60'0"
Arch/MEP: 40% / 60%	LEED: NA	Historic Significance:

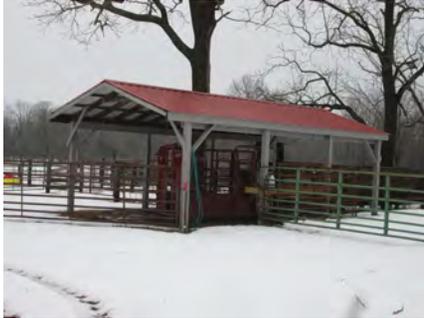
1120: Working Chute 2 **80.66%**

Address: Godown Road, Columbus	Area: 288	Construction Type: Wood frame w / Wood skin
Auditor: DMD & MAM	Date Constructed: 2010	Construction Type 2:
Audit Date: 03/04/2015	Last Renovation: NA	Structural Span: 24'
Arch/MEP: 40% / 60%	LEED: NA	Historic Significance: NA

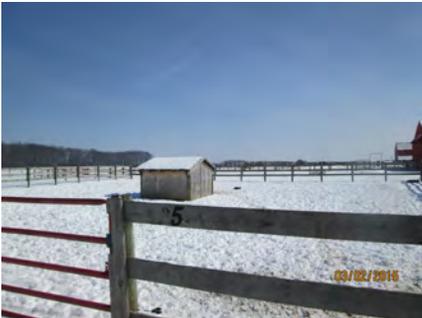
1124: Pony Run-In Sheds **72.90%**

Address: 3658 Kays Avenue, Columbus	Area: 160	Construction Type: Wood frame w / Wood skin
Auditor: DMD & MAM	Date Constructed: 1980	Construction Type 2:
Audit Date: 03/02/2015	Last Renovation: NA	Structural Span: 10'
Arch/MEP: 40% / 60%	LEED: NA	Historic Significance: NA

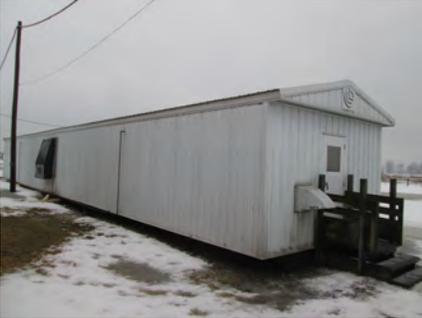
1311: Swine Nursery C **74.12%**

The Swine Nursery C is an engineered modular trailer with a low gable roof which rests on CMU block piers. The exterior of this trailer is clad in standing seam metal wall and roofing systems. The structure is insulated and moisture resistant panels with seam covers are installed on all interior surfaces. This trailer is used as an animal nursery. There are steel tube animal pens with automatic watering and feeding systems. The structure is heated by electric unit heaters and large intake and exhaust fans circulate air. The trailer has adequate electrical service, with room for expansion. The trailer is being used as designed and is in good condition. The facility assessment team was escorted by and interviewed Mr. Ken Mays, Swine Operations Manager, while conducting their field work.

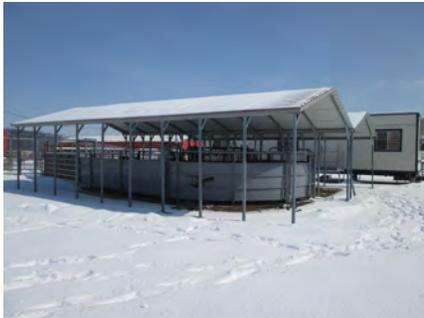
1312: Working Chute 1

Working Chute 1 consists of two, steel framed, gable roofed, shelters with open sides and standing seam metal siding installed on the roofs. These structures sit side by side, with their gable peaks facing north and south. The standing seam metal siding is run horizontally and supported by the steel framing members. These shelters cover cattle working equipment with a squeeze chute. There are no mechanicals associated with this structure. The structure is designed to provide cover from the elements while working with the animals. It is functioning as intended and is in good condition.

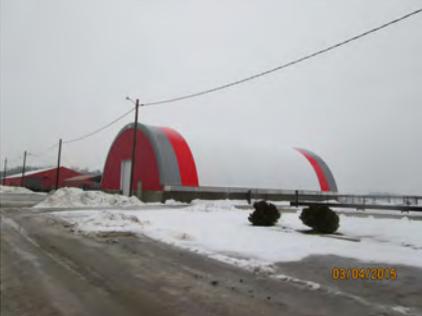
1317: Hoop Structure **94.79%**

The interior walls are the exposed, cast in place, reinforced concrete knee walls with brick face stamping, 2"x6" west end wall framing, and the underside of the exterior standing seam metal end wall siding and fabric coverings for the hoop structure. These are in very good condition. There are also wooden posts with steel tube animal pen gates which are in good condition.

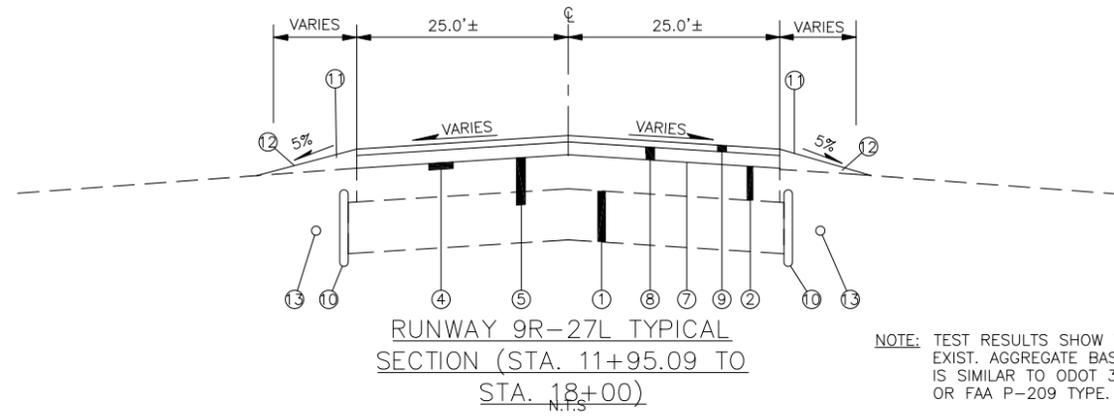
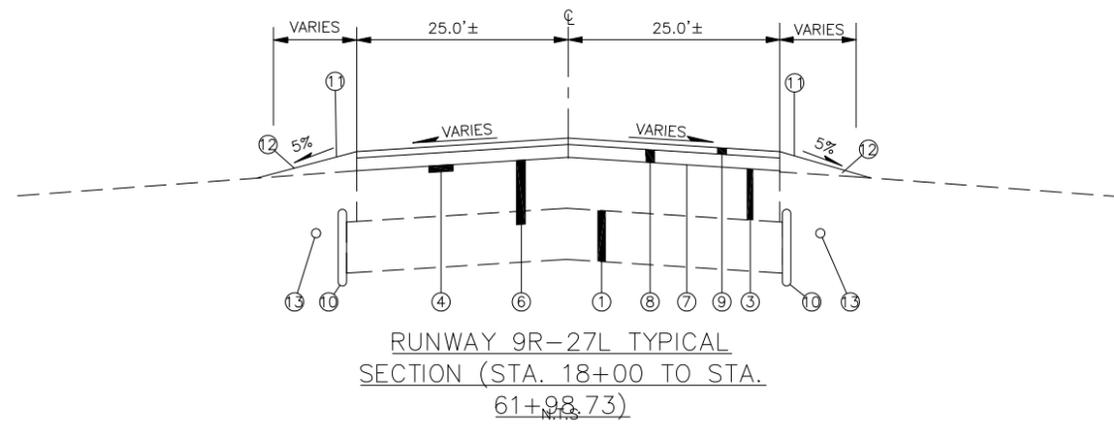
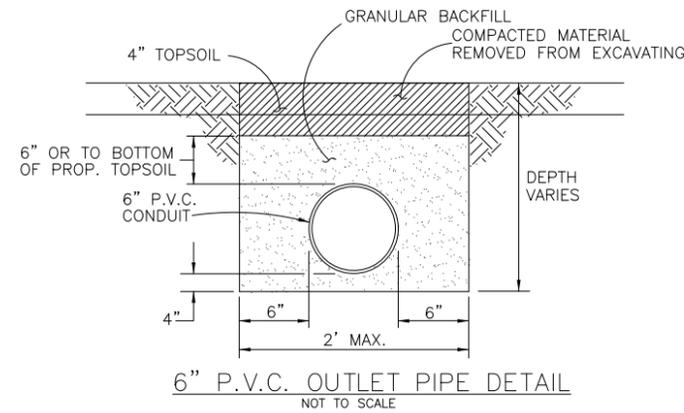
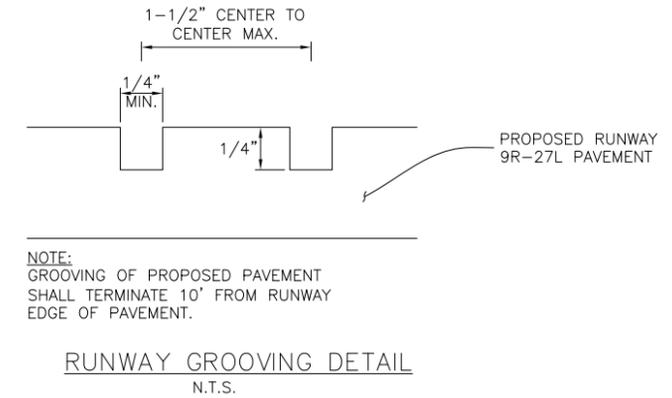
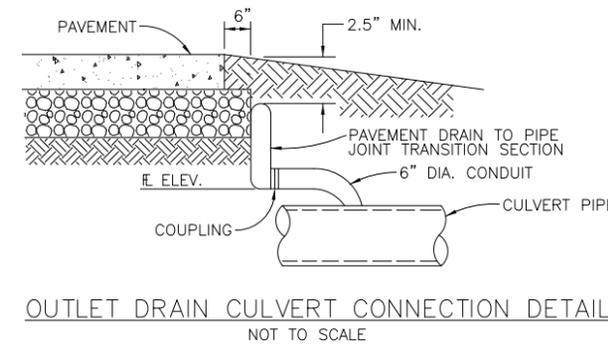
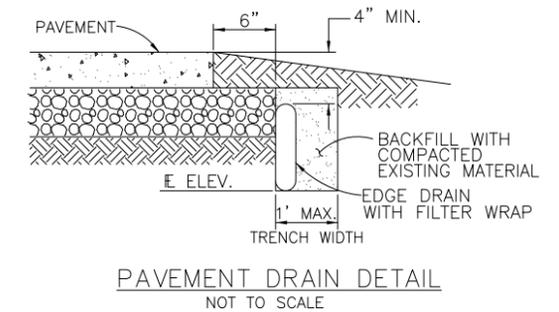
EXHIBIT 1

NOTE: AFTER INITIAL PULVERIZING, CONTRACTOR MUST GRADE PULVERIZED AREA PRIOR TO STABILIZATION.

- ① EXISTING AGGREGATE BASE (6"±)
- ② EXISTING ASPHALT CONCRETE 8"±.
- ③ EXISTING ASPHALT CONCRETE 12"±
- ④ P-151 PAVEMENT MILLING (VARIES 0" TO 4")
- ⑤ ITEM Z-155 PAVEMENT RECLAMATION (APPROX DEPTH=10". EXACT DEPTH PER APPROVED JMF)
- ⑥ ITEM Z-155 PAVEMENT RECLAMATION (APPROX DEPTH=14". EXACT DEPTH PER APPROVED JMF)
- ⑦ P-602 BITUMINOUS PRIME COAT
- ⑧ P-401-1 3" BITUMINOUS INTERMEDIATE COURSE
- ⑨ P-401-2 1.5" BITUMINOUS SURFACE COURSE
- ⑩ ITEM D-705 18" PAVEMENT DRAIN
- ⑪ BERMING
- ⑫ HYDRO SEEDING
- ⑬ EXIST. 4" PERFORATED PVC (6" TO 18" FROM E.P.)

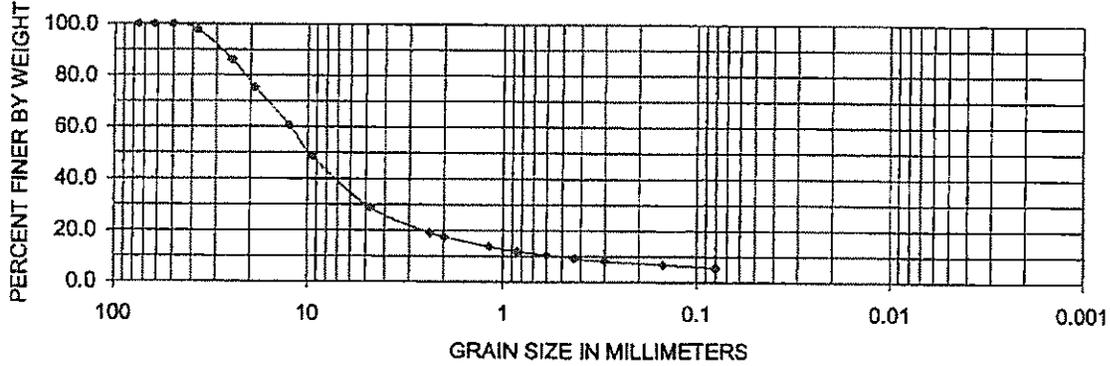
Sample Description: 53% puverized asphalt, 47% base
Sample Location: C-1 to C-8
Sample #: 7446

SIEVE ANALYSIS ASTM C136

Sieve	Sieve size, mm	Total Percent Passing	Total Percent Retained	Individual Percent Retained
3	75	100.0	0.0	0.0
2-1/2"	62.5	100.0	0.0	0.0
2"	50	100.0	0.0	0.0
1-1/2"	37.5	97.8	2.2	2.2
1"	25	86.1	13.9	11.7
3/4"	19	75.4	24.6	10.7
1/2"	12.5	60.5	39.5	14.9
3/8"	9.5	48.5	51.5	12.0
#4	4.75	28.8	71.2	19.6
#8	2.36	19.1	80.9	9.8
#10	2	17.4	82.6	1.6
#16	1.18	13.6	86.4	3.8
#20	0.85	11.9	88.1	1.7
#30	0.6	10.5	89.5	1.5
#40	0.43	9.2	90.8	1.3
#50	0.3	8.2	91.8	1.0
#100	0.15	6.8	93.2	1.4
#200	0.08	5.6	94.4	1.2

$D_{60} = 12.50$
 $D_{30} = 5.00$
 $D_{10} = 0.59$

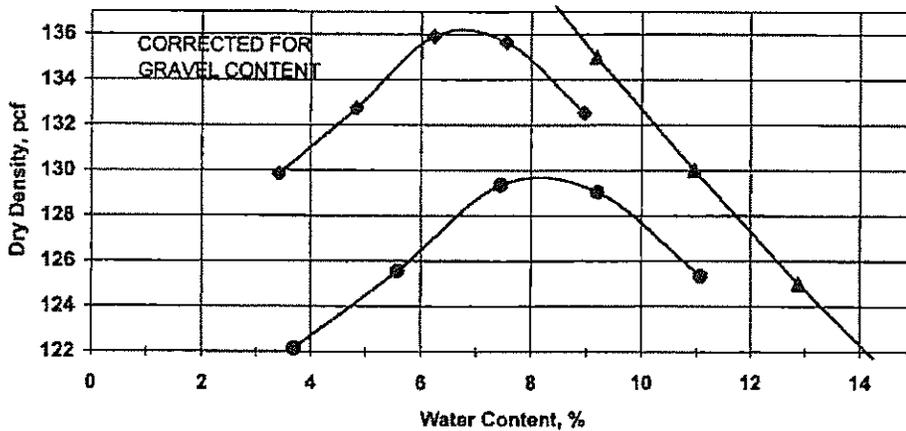
Proctor Method	ASTM 1557C
Maximum Dry Density, pcf	136.2
Optimum Moisture, %	6.7
As Rec'd w%	---
Grain Size	
Percent Ret'd on 3/4"	25
Percent Ret'd on 3/8"	52
Percent Ret'd on #4	71
Liquid Limit	---
Plastic Limit	---
Plasticity Index	---

This test was conducted in accordance with ASTM D1557. The maximum dry density and optimum moisture content have been corrected when appropriate to account for the oversize fraction of material excluded from the test sample.

MOISTURE-DENSITY RELATIONSHIP

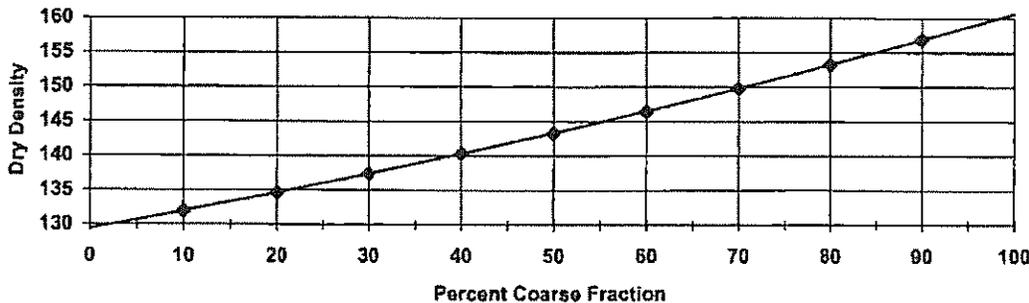
GRAVEL CORRECTION WITH MATERIAL RETAINED ON 3/4

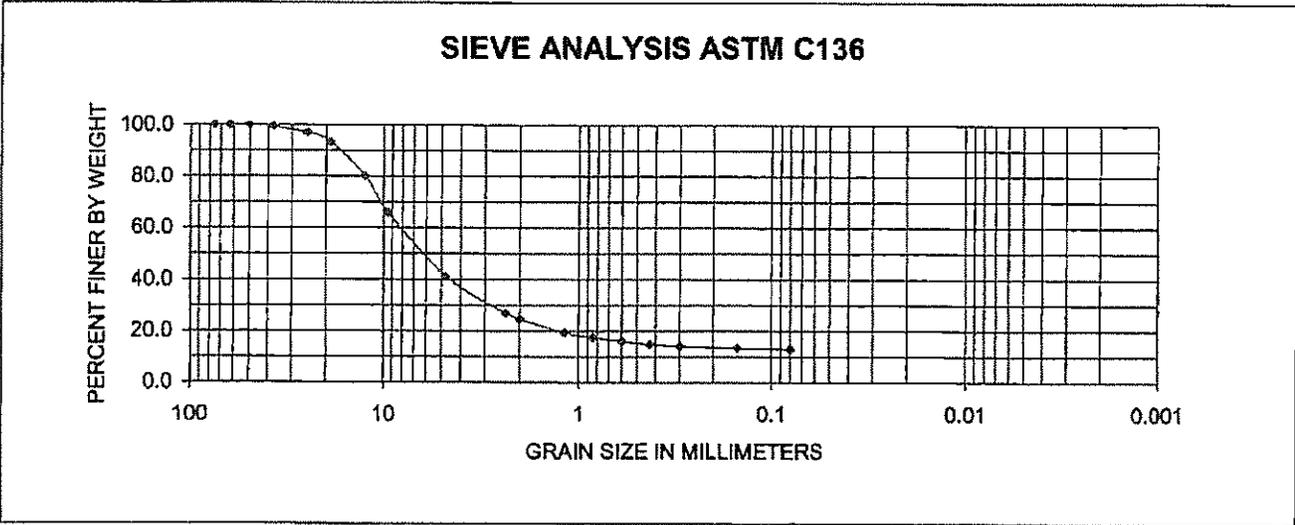
Sample Description: 73% Asphalt and 27% Base
Sample Location: C-9 to C-26
Sample #: 7447

Sieve	Sieve size, mm	Total Percent Passing	Total Percent Retained	Individual Percent Retained
3	75	100.0	0.0	0.0
2-1/2"	62.5	100.0	0.0	0.0
2"	50	100.0	0.0	0.0
1-1/2"	37.5	99.4	0.6	0.6
1"	25	97.0	3.0	2.4
3/4"	19	93.3	6.7	3.7
1/2"	12.5	80.3	19.7	13.1
3/8"	9.5	66.0	34.0	14.3
#4	4.75	41.2	58.8	24.8
#8	2.36	26.9	73.1	14.3
#10	2	24.6	75.4	2.3
#16	1.18	19.4	80.6	5.2
#20	0.85	17.3	82.7	2.0
#30	0.6	15.9	84.1	1.4
#40	0.43	14.9	85.1	1.0
#50	0.3	14.2	85.8	0.7
#100	0.15	13.4	86.6	0.8
#200	0.08	12.9	87.1	0.4

$D_{60} = 8.10$
 $D_{30} = 3.00$
 $D_{10} = \text{---}$

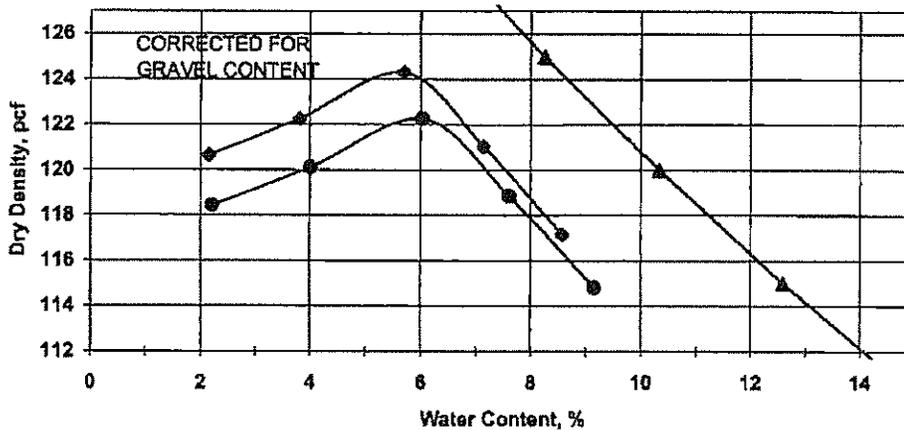
Proctor Method	ASTM 1557C
Maximum Dry Density, pcf	124.3
Optimum Moisture, %	5.6
As Rec'd w%	---
Grain Size	
Percent Ret'd on 3/4"	7
Percent Ret'd on 3/8"	34
Percent Ret'd on #4	58
Liquid Limit	---
Plastic Limit	---
Plasticity Index	---

This test was conducted in accordance with ASTM D1557. The maximum dry density and optimum moisture content have been corrected when appropriate to account for the oversize fraction of material excluded from the test sample.

MOISTURE-DENSITY RELATIONSHIP

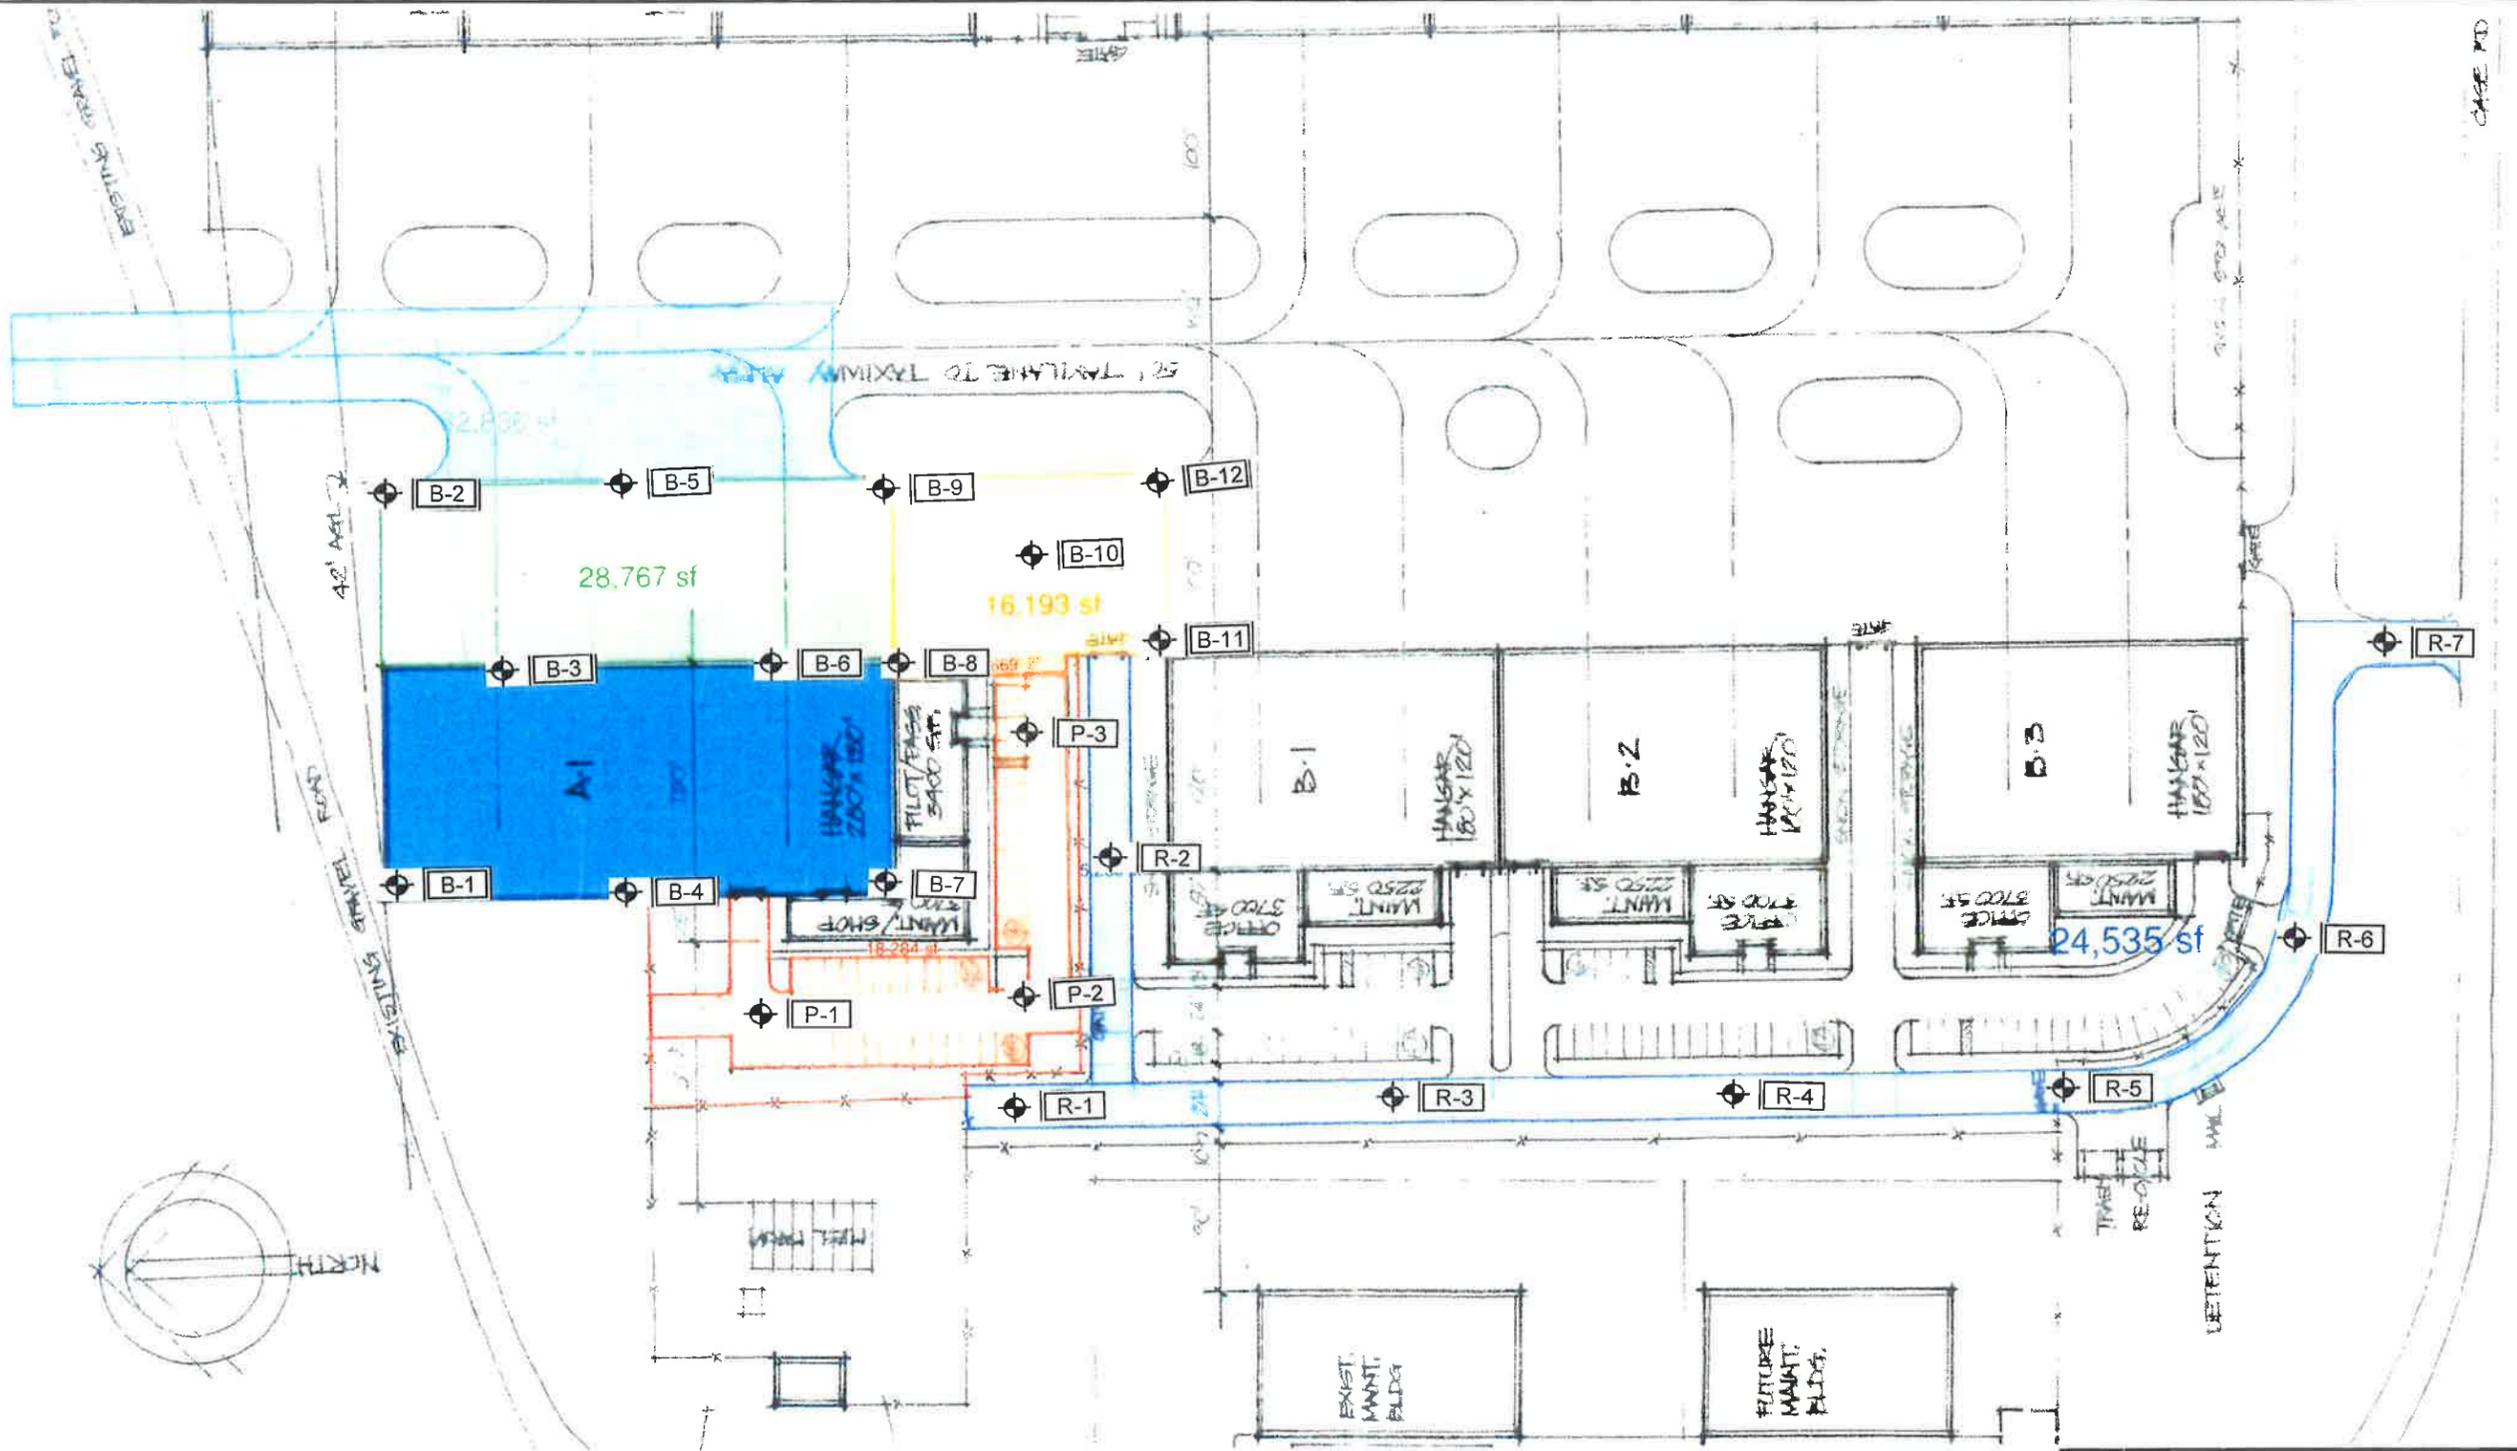
BORING LOCATION PLAN	
OSU Airport Hangar Project	
West Case Road - Columbus, Ohio	
Base map by Brandstetter Carroll Inc	
Project No.: 18-G-22020	
Date: 7/12/18	Drawn By: CLM
Scale: 1"=100' (approximate)

⊕ Approximate Boring Location

We have attached boring logs, a copy of the Boring Location Plan, and a summary table of encountered subsurface conditions in the appendix. We summarize the subsurface findings below. Refer to the individual boring logs for more detailed subsurface information at specific boring locations.

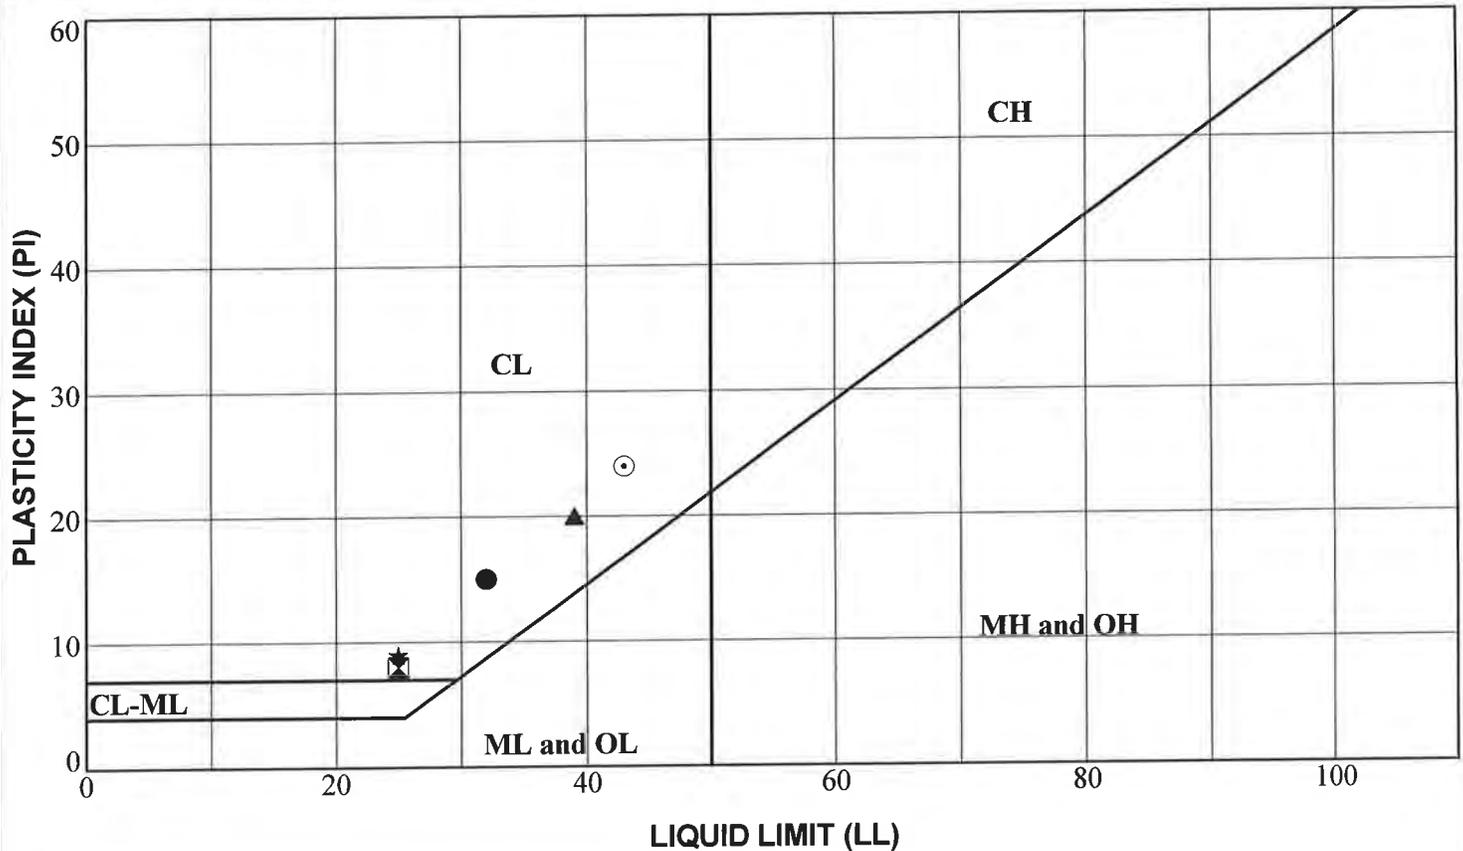
TEST HOLE	DEPTH	w _n	LL	PL	PI	ASTM CLASSIFICATION
● B- 3	2.0	21.7	32	17	15	CL
⊠ B- 3	4.0	16.7	25	17	8	CL
▲ B- 8	2.0	24.1	39	19	20	CL
★ B- 8	4.0	19.1	25	16	9	CL
⊙ R- 3	1-4'	22.0	43	19	24	CL

Under the ASTM/Unified Classification System, we classified the natural clay-based soils as lean clay with sand and sandy lean clay (both are classified as CL in the Unified/ASTM Soils Classification System), which are generally consistent with our visual classifications. Natural moisture contents in the upper 4 feet of the soil profiles ranged from 16.7 percent to 24.1 percent. The moisture of the soils below about 4 feet range from 8.9 percent to 12.1 percent. Typically, clayey soils with moisture contents above 20% can be difficult to work with and may require moisture conditioning to use as structural fill.

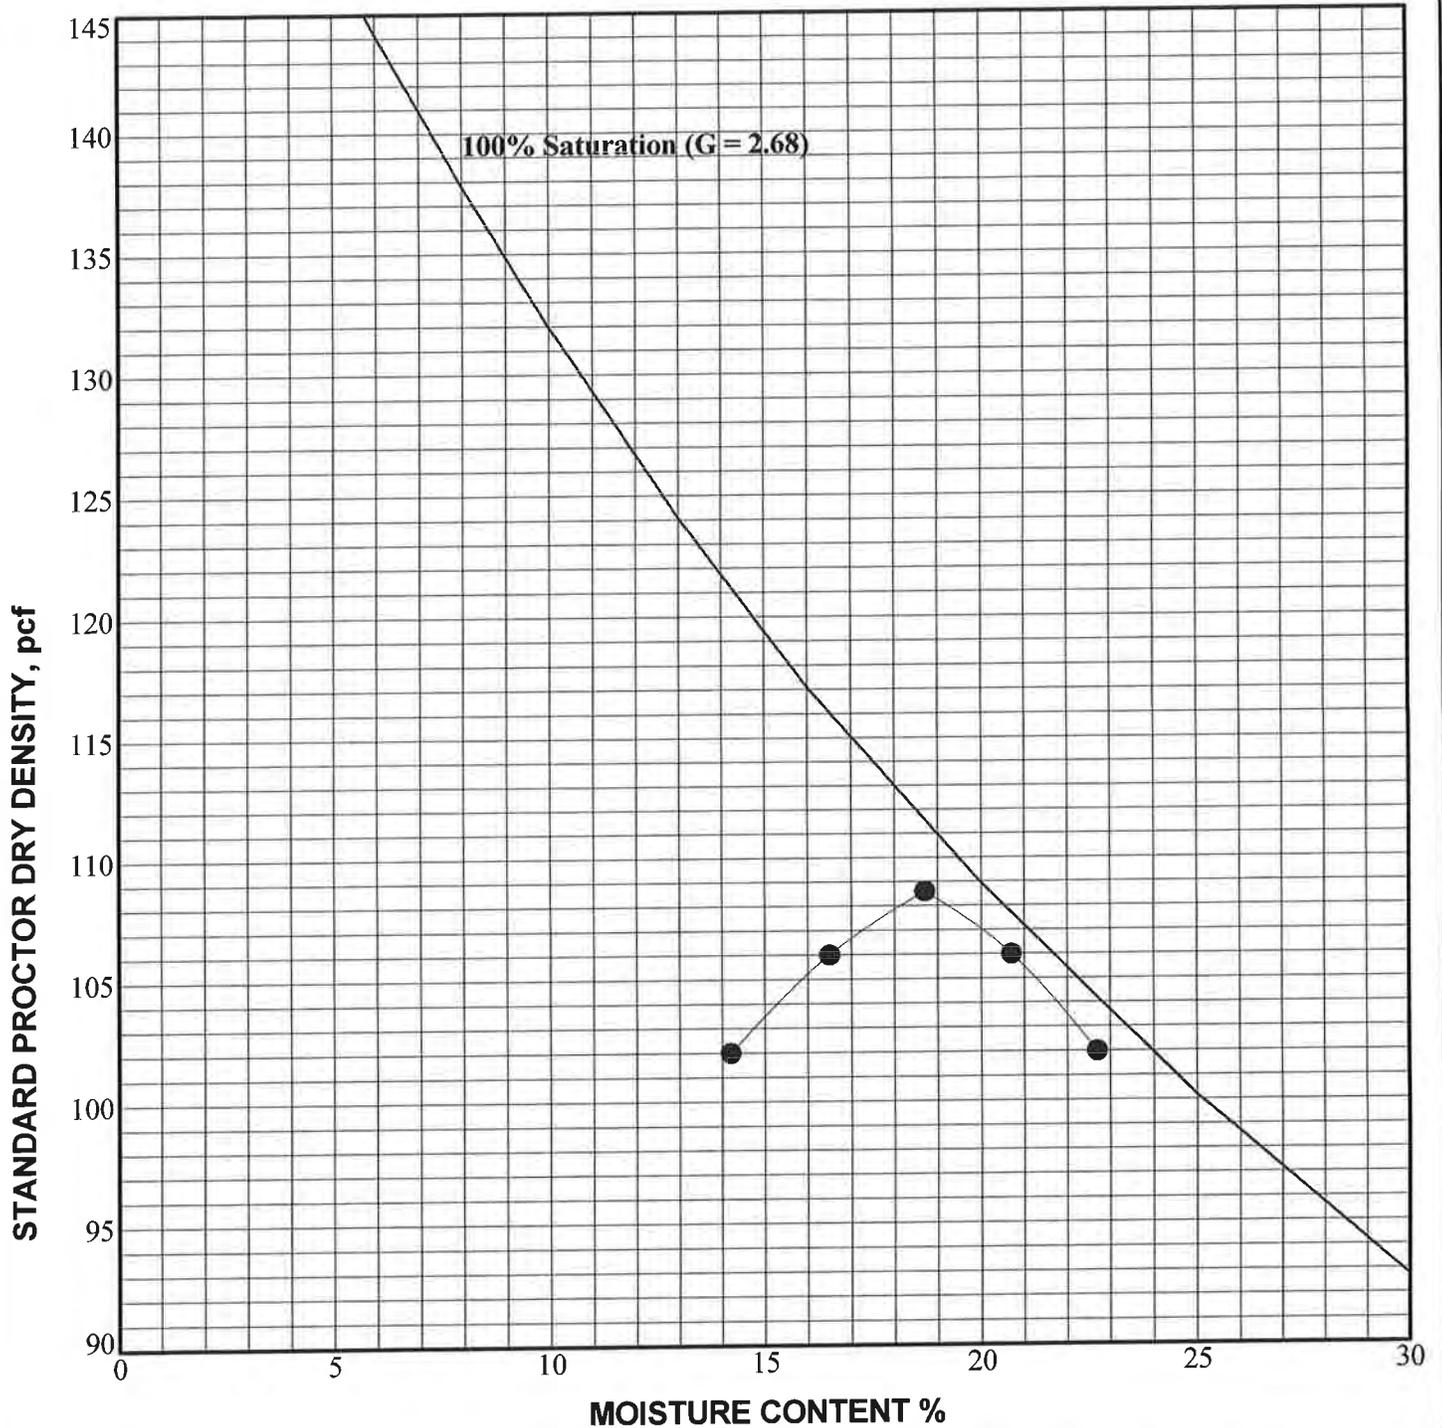
Test Hole	Depth	ASTM Classification	Maximum Dry Density, pcf	Optimum Moisture Content, %	Natural Moisture Content, %	CBR
● R-3	1-4'	CL	108.6	18.7	22.0	5.0

The bulk sample testing resulted in a Standard Proctor Maximum Dry Density of 108.6 pounds per cubic foot (PCF), occurring at an optimum moisture content of 18.7%. The natural moisture content of the bulk sample was 22%, suggesting some moisture conditioning could be required to properly prepare the subgrade soils and achieve compaction. CBR testing resulted in a value of 5.0, with a low volume change potential of 1.3%.
