Appendix D – Non-Airport Building Assessments

0206: Laboratory Animal Center 6**75.33%**

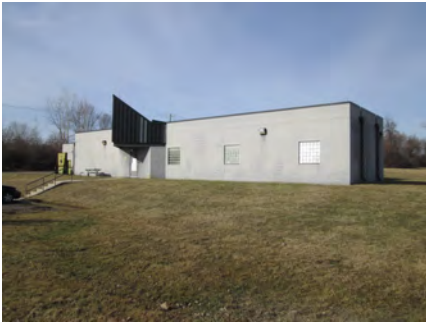
Address:
6089 Godown
Road, Columbus

Construction Type:
Load-bearing Masonry Block frame w / Masonry skin

**Date
Constructed:**
1996

Structural Span:
Varies 24'0", 12'0", 8'0"

The Laboratory Animal Center Building 6 was originally built for animal research with a BSL 3 laboratory. The building is now leased to Q-Test Research Labs who have occupied it for the past five years. The structure is a CMU block building with an interstitial space to house mechanical for the laboratory equipment. The perimeter and interior load bearing walls are CMU block with pre cast concrete ceiling panels. The interstitial spaces have metal stud framed walls and gable roofs which are fully sheathed and have standing seam metal wall and roofing systems installed over them. The exterior walls have been painted, however, this finish is fading and should be refreshed with new paint when feasible. The flat roofs of the structure have modified bitumen, built up roofing systems installed which are beginning to show their age but remain adequate. Scuppers with downspouts direct storm water off the roof, however, this water is deposited directly onto the ground at the structure causing erosion. Interior walls are painted CMU, some with an epoxy coating. The BSL 3 lab has an airlock door system and the exhaust from this area is treated with hepa filters prior to being released into the air. Two boilers provide heating hot water for the building while a third boiler provides steam for the lab cleaning appliances, cage washers, and humidifiers. These are in good condition. The interior is equipped with explosion proof devices covering the lighting, emergency equipment, and outlets. There is a large lift located on the dock to load animal cages. Interior finishes are in good condition. There are locker rooms for both sexes which have ADA compliant water closets and shower stalls. The structure has various lab equipment including, large cage washer, autoclave, surgical tables and equipment, walk in freezers and refrigerators, and stainless steel or composite cabinets and countertops. The structure and its contents are well maintained and in good condition. The facility assessment team was escorted by and interviewed Mr. Jason Chipps with University Laboratory Resources while conducting their field work.

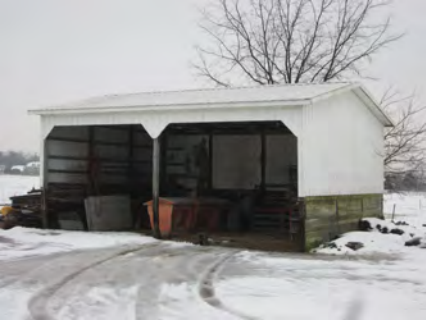
0329: Vehicle Storage **63.43%**

<p>Address: 3667 Kays Avenue, Columbus</p> <p>Auditor: DMD & MAM</p> <p>Audit Date: 03/04/2015</p> <p>Arch/MEP: 40% / 60%</p>	<p>Area: 768</p> <p>Date Constructed: 1971</p> <p>Last Renovation: NA</p> <p>LEED: NA</p>	<p>Construction Type: Wood frame w / Metal skin</p> <p>Construction Type 2:</p> <p>Structural Span: Varies 24'0"</p> <p>Historic Significance: NA</p>
---	---	---

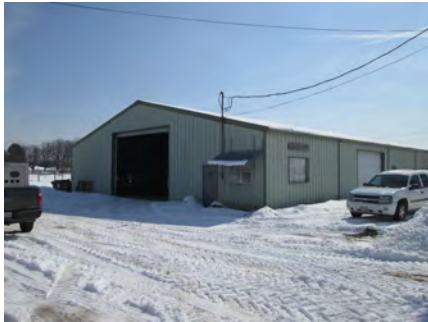
0982: Sheep Annex

Address: 2400 West Case Road, Columbus	Area: 6200	Construction Type: Steel frame w / Metal skin
Auditor: DMD & MDM	Date Constructed: 1976	Construction Type 2:
Audit Date: 03/02/2015	Last Renovation: NA	Structural Span: Varies 60'0"
Arch/MEP: 40% / 60%	LEED: NA	Historic Significance:

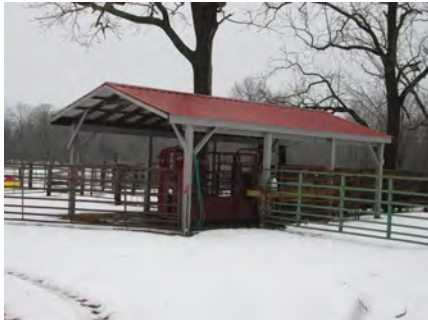
1120: Working Chute 2

Address: Godown Road, Columbus	Area: 288	Construction Type: Wood frame w / Wood skin
Auditor: DMD & MAM	Date Constructed: 2010	Construction Type 2:
Audit Date: 03/04/2015	Last Renovation: NA	Structural Span: 24'
Arch/MEP: 40% / 60%	LEED: NA	Historic Significance: NA

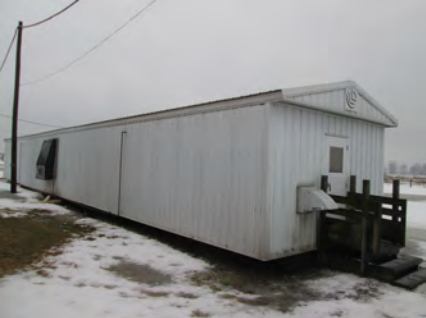
1311: Swine Nursery C **74.12%**

<p>Address: 3669 Kays Avenue, Columbus</p> <p>Auditor: DMD & MAM</p> <p>Audit Date: 03/04/2015</p> <p>Arch/MEP: 40% / 60%</p>	<p>Area: 1290</p> <p>Date Constructed: 2000</p> <p>Last Renovation: NA</p> <p>LEED: NA</p>	<p>Construction Type: Steel frame w / Metal skin</p> <p>Construction Type 2:</p> <p>Structural Span: Varies 16'0"</p> <p>Historic Significance: NA</p>
---	--	--
